Analysis of Surveyor 3 material and photographs returned by Apollo 12

NATIONAL AERONAUTICS AND SPACE ADMINISTRATION

1972

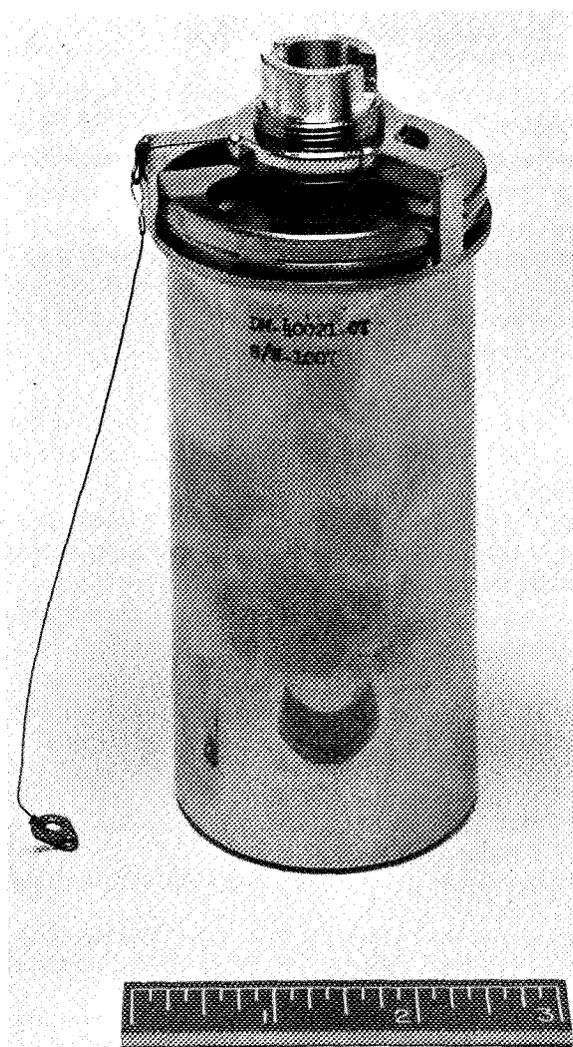
FIGURE 6.—Apollo sealed environmental sample container (SESC), containing Surveyor 3 cabling and painted tube, just before container was opened at JPL. The SESC is 15½ cm high and is 6.0 cm wide at its base.

The sealed SESC, containing the cable and painted tube, was opened at JPL in a sterile glove box under high purity argon and red light. It was found that the SESC had leaked, admitting air or air and oxygen; apparently a good seal was not obtained on the Moon.⁴ The cable and painted tube were sectioned in the glove box; parts not tested there were resealed for further distribution. (See ch. XI, pt. B, of this document.)

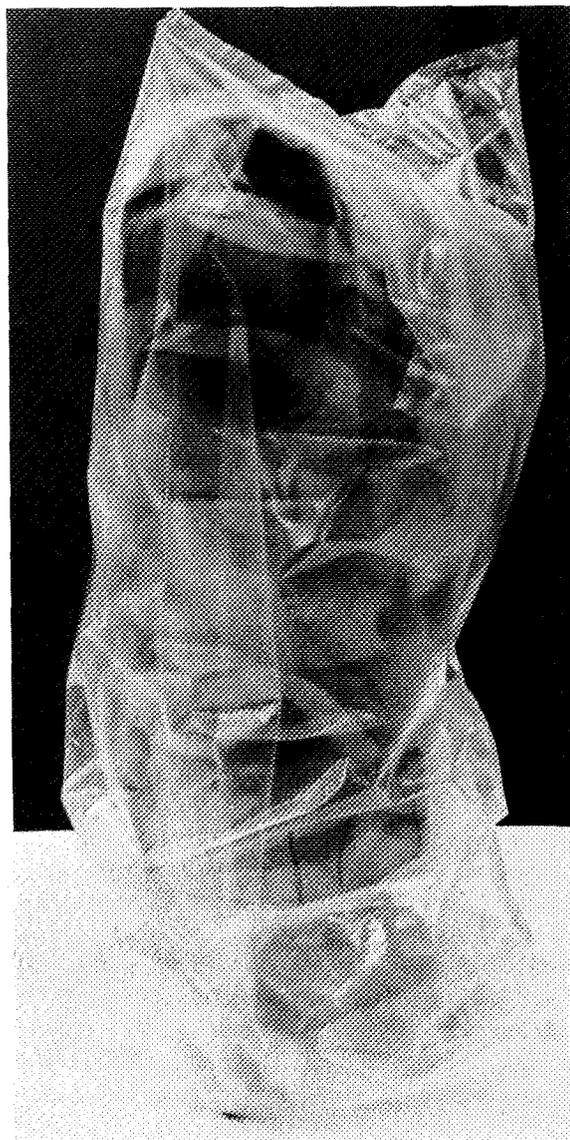
FIGURE 7.—Returned Surveyor 3 television camera, sealed in polyethylene bag. Photograph was taken in the LRL after the camera was returned from the Moon.

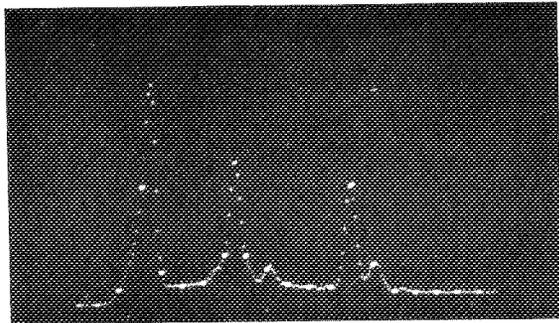
FIGURE 6.—(a) X-ray diffraction unit showing camera (center) in place. (b) X-ray diffraction spectrum.

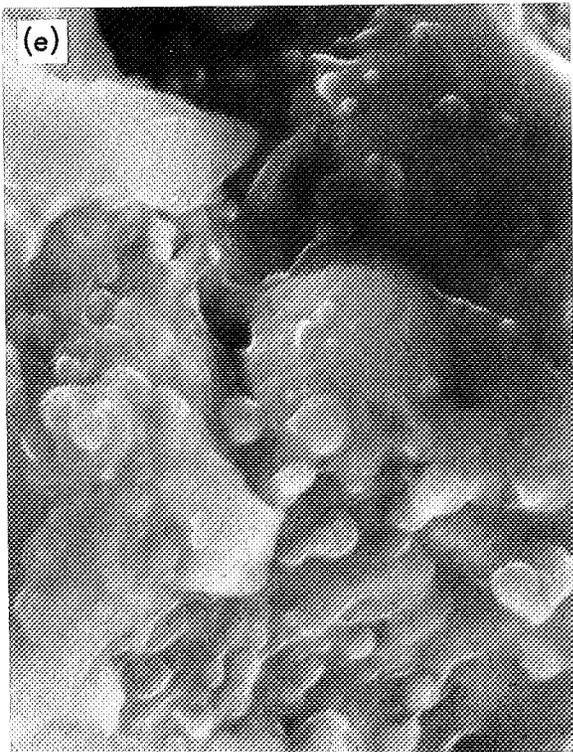
FIGURE 8.—Scanning electron microscope photomicrographs of typical particles. (a) Particle 67 at 4000 \times . (b) Particle 67 at 10 000 \times . (c) Particle 67 at 25 000 \times . (d) Particle 77 at 2000 \times . (e) Particle 77 at 15 000 \times . (f) Particle 52 at 4000 \times . (g) Particle 52 at 15 000 \times .

FIGURE 8.—Concluded.

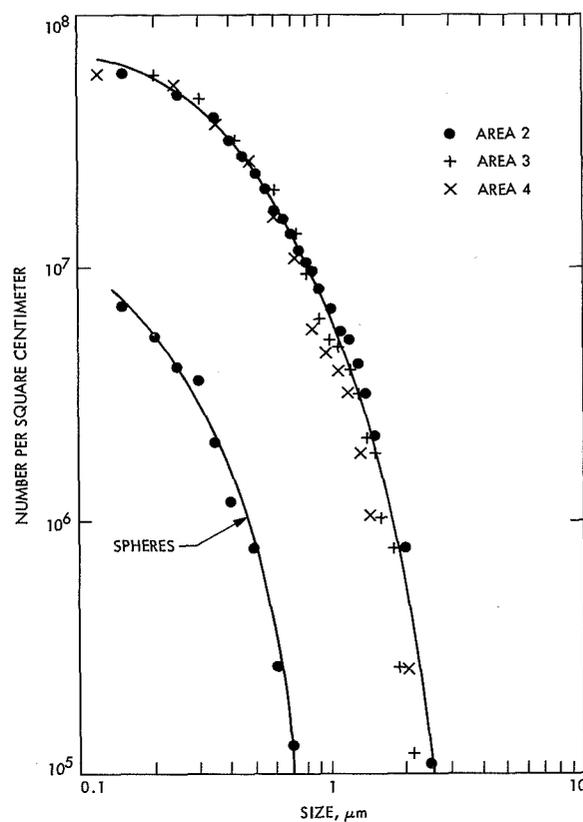
FIGURE 5.—Cumulative size-frequency distribution of debris on different parts of the mirror. Curve for spheres is average for all areas.

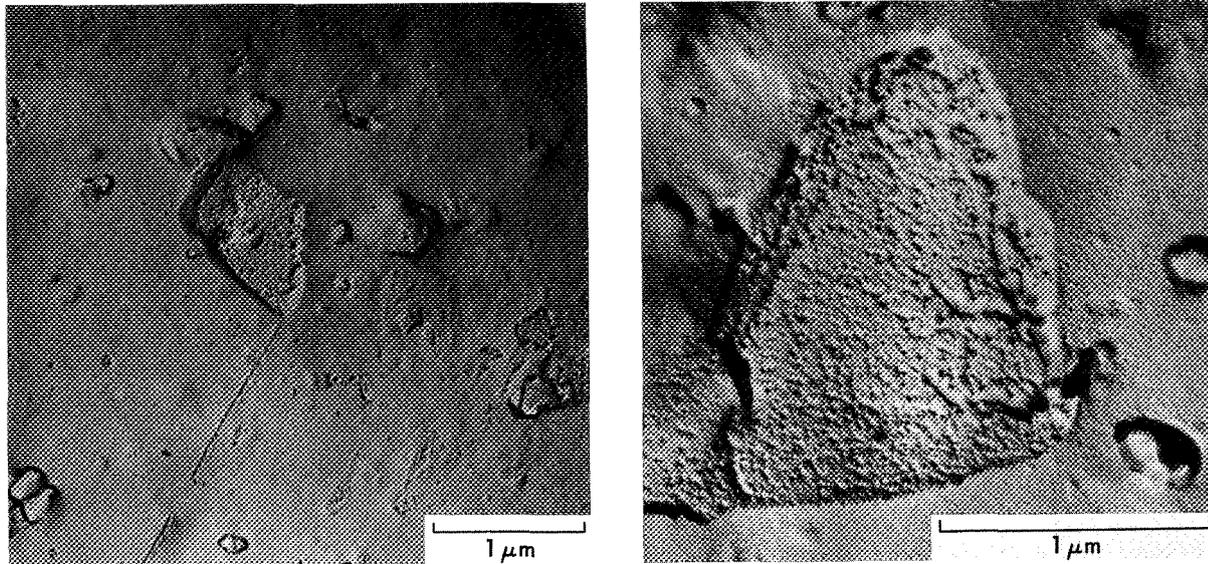
FIGURE 6.—Defects in the surface of the mirror.

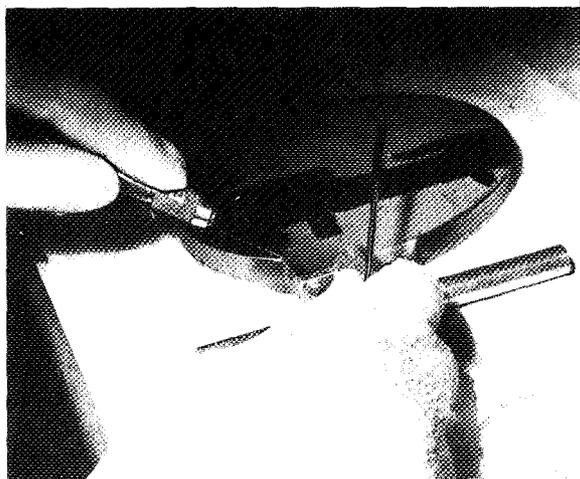
FIGURE 5.—The scraping technique used by chemists to define the composition of the nonparticulate film. Results of this test were not available at the time of this writing.

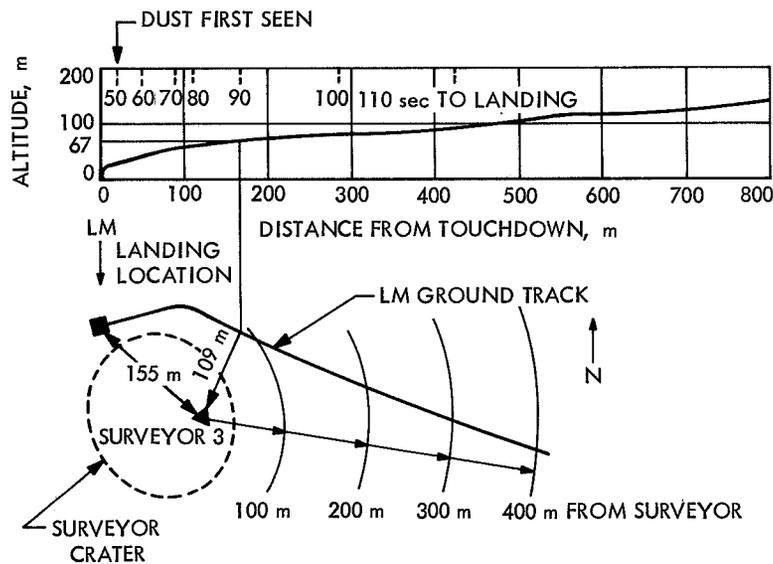
FIGURE 15.—A profile and plan view of the Apollo 12 approach trajectory and landing site in relation to the Surveyor 3 spacecraft. The closest point along the ground track was about 109 m, while the LM was at an elevation of 67 m.

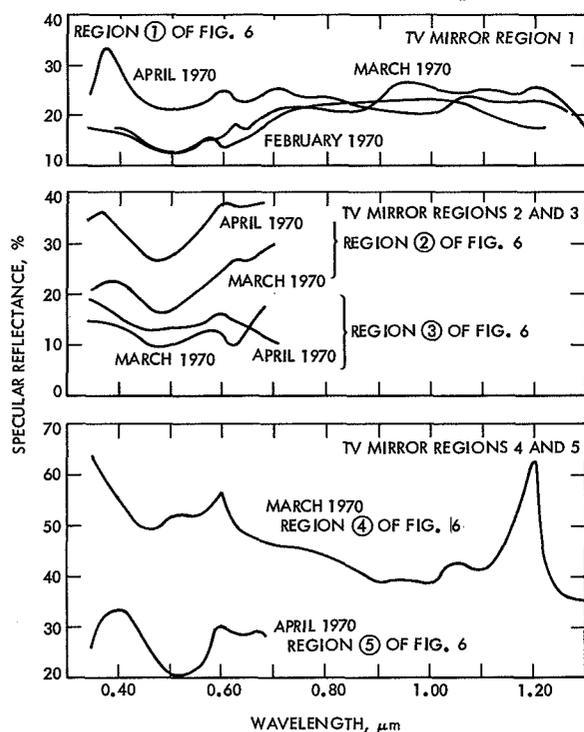
FIGURE 5.—Measurements of the spectral reflectance on the mirror made by Hughes Aircraft Co. over the period of February through April 1970. Incidence angle equals reflectance angle. (Data are through the courtesy of Hughes Aircraft Co.)

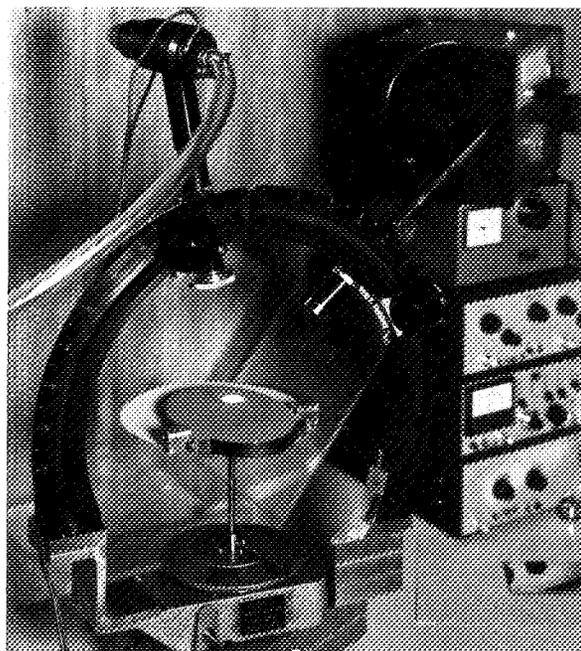
FIGURE 8.—Goniophotometer used in the photometric tests on the mirror. The detector fiber optics probe (right) is coupled to the entrance slit of a monochromator.

shows much more detail in its mirror image than visible light. Measurements were made at HAC to confirm this observation. A goniophotometer (see fig. 8) was used to make angular measurements of the reflected light flux at three narrow wavelengths. Two positions on the mirror were chosen. As figure 9 shows, much more light was scattered at the wavelength centered at 413 nm than at 625 nm. Incidence angles of 30° and 60° indicated that at least 50 percent more light at 413 nm was scattered at the larger angle. The amount of scattered light at 60° incidence appears to respond like the exponential function e^{-x} , where x is the sum of the absorption and total scattering coefficients. No estimate of the particle size distribution was made from

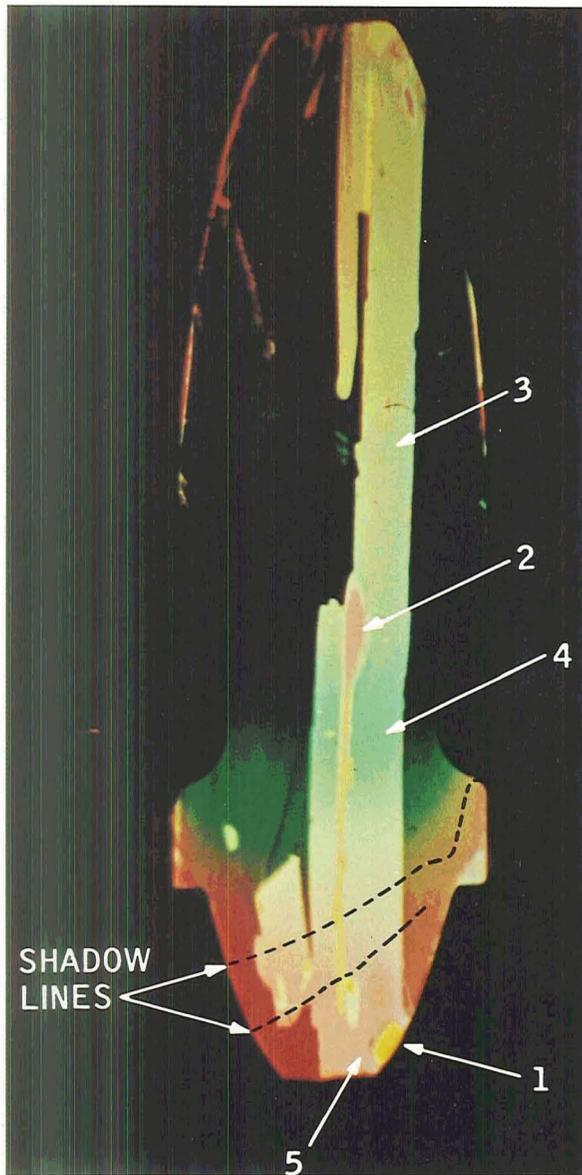
FIGURE 19.—The photograph at left shows the colors observed by the white light ellipsometry experiment. The numbered areas correspond to the curves in figure 20. Two faint boundaries of lunar fines are marked and discussed in the test. Sketch above is assumed cross section of the mirror. Not shown to scale.

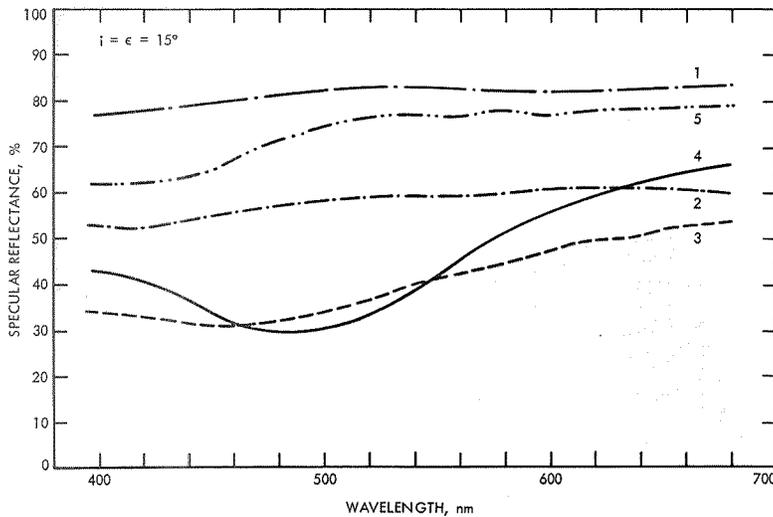
FIGURE 20. — Spectral reflectance curves of areas marked in figure 19, after replication and rubbing. The incidence and reflectance angles = 15° .

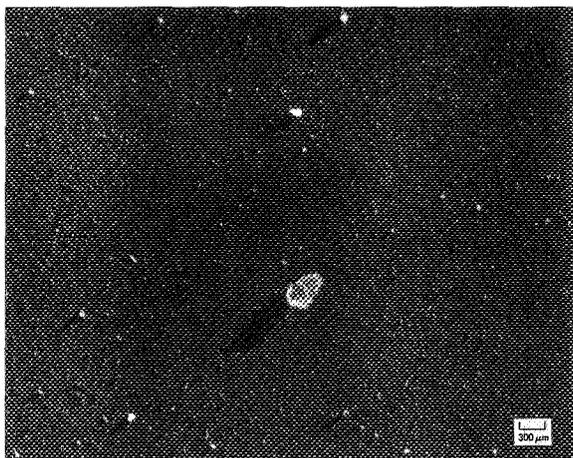
FIGURE 23.—Microphotograph of a clear feldspar grain. The fragment is about 440 by 280 μm ; the small sphere, about 2 cm “up Sun” from the large fragment, is about 30 μm in diameter.

material (similar to other lunar fines) was discovered by this photography. Figure 22 shows a lunar rock fragment and numerous glass spheres. The fragments in the figure are probably pyroxene grains, while those in figure 23 resemble a clear feldspar. Much of the material has pitted surfaces even to those of the spheres (fig. 24). Also of interest is the accumulation of lunar fine material around the base of the spheres. (See fig. 25.) The five prominent specks of material located on the mirror from the top of Conrad's swipe to the left elevation axis trunnion (see fig. 10) are especially interesting. These specks were on the mirror at the first unpacking at the LRL. (See fig. 26.)

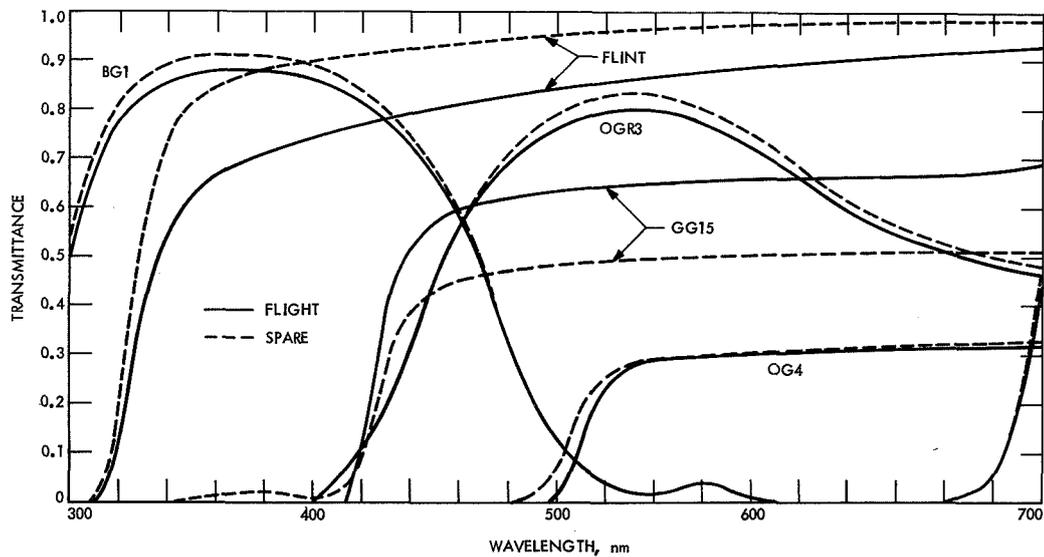
FIGURE 30.—Spectral transmission of the flight and spare set of filter glasses, with the exception of 3-76.

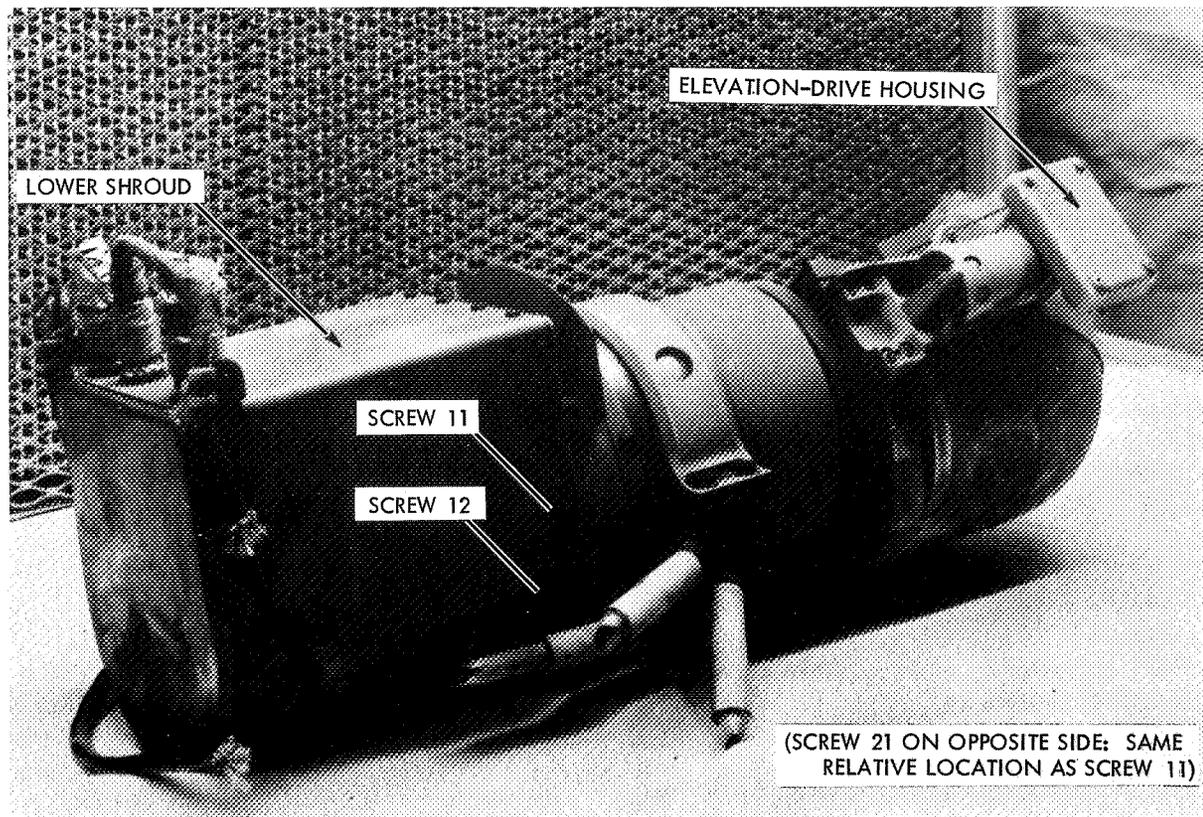
FIGURE 2.—Surveyor 3 television camera, showing location of specific parts of the camera examined in the study by Ames Research Center.

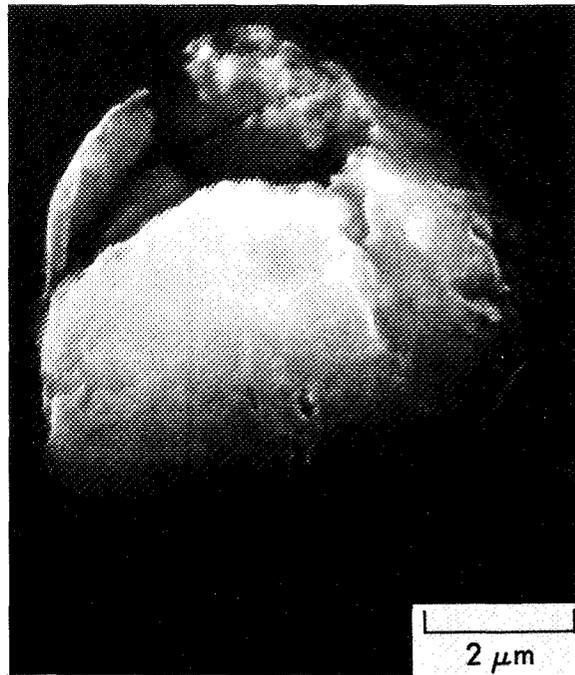
FIGURE 4.—Scanning electron micrograph of a particle embedded in the surface of section B of the RADVS support tube.

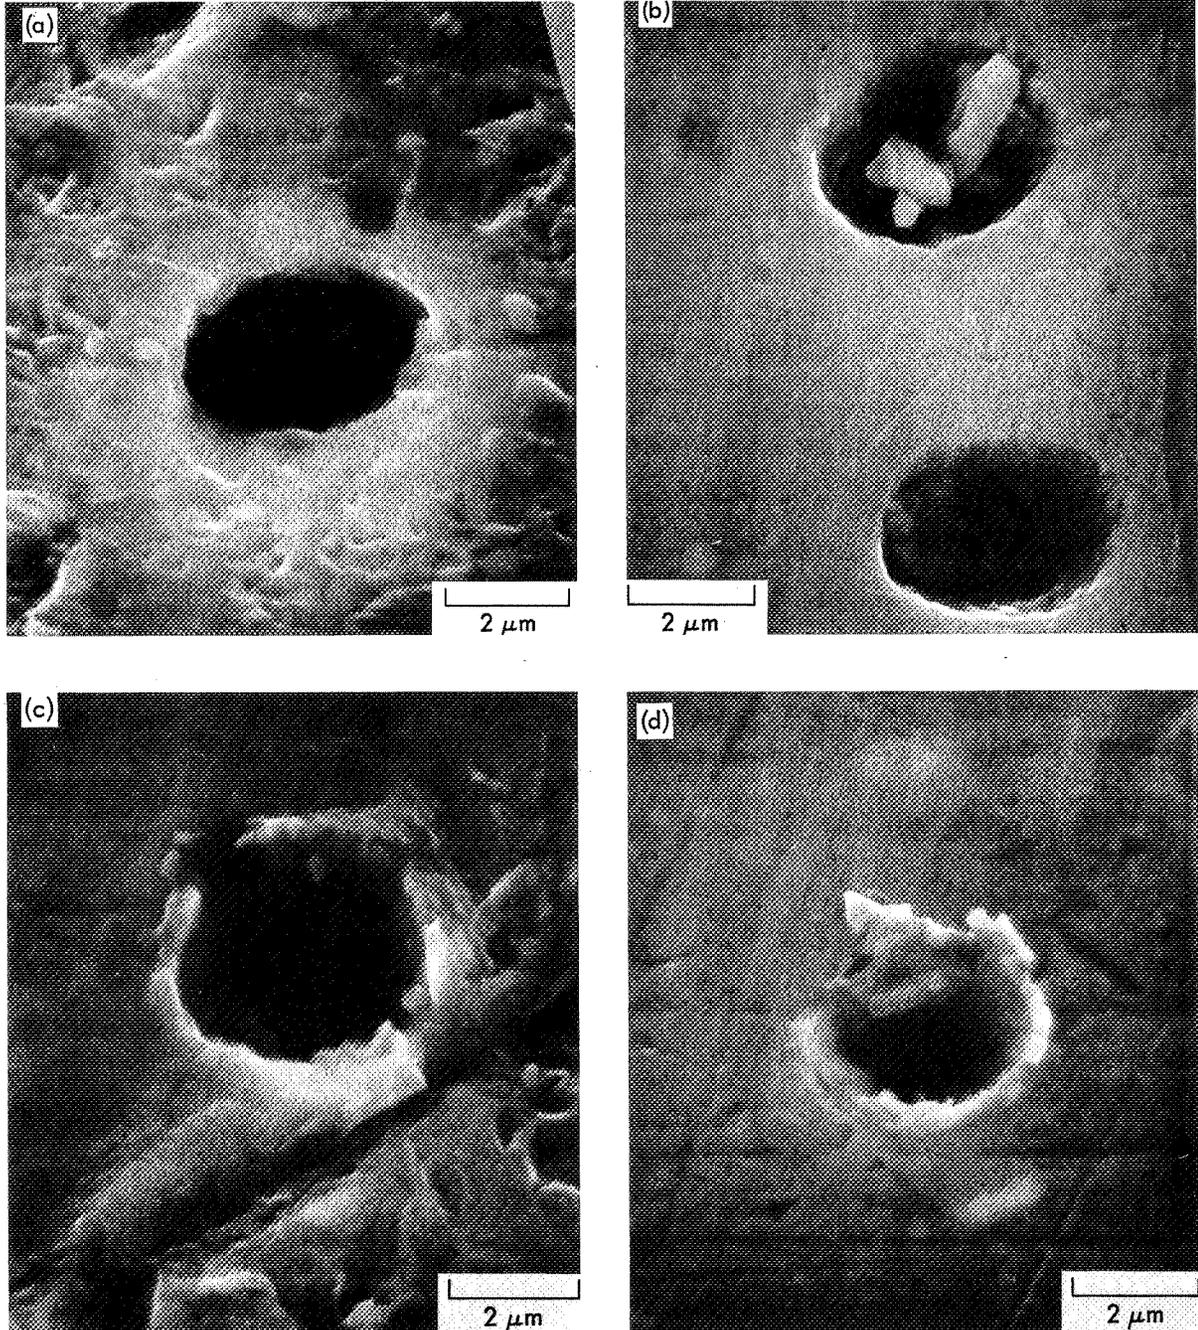
FIGURE 5.—Scanning electron micrographs of "dirty" and "clean" sides of RADVS section B. (a) "Unrimmed" hole on dirty side. (b) "Unrimmed" holes on clean side. (c) "Semi-rimmed" hole on clean side. (d) "Rimmed" hole on clean side.

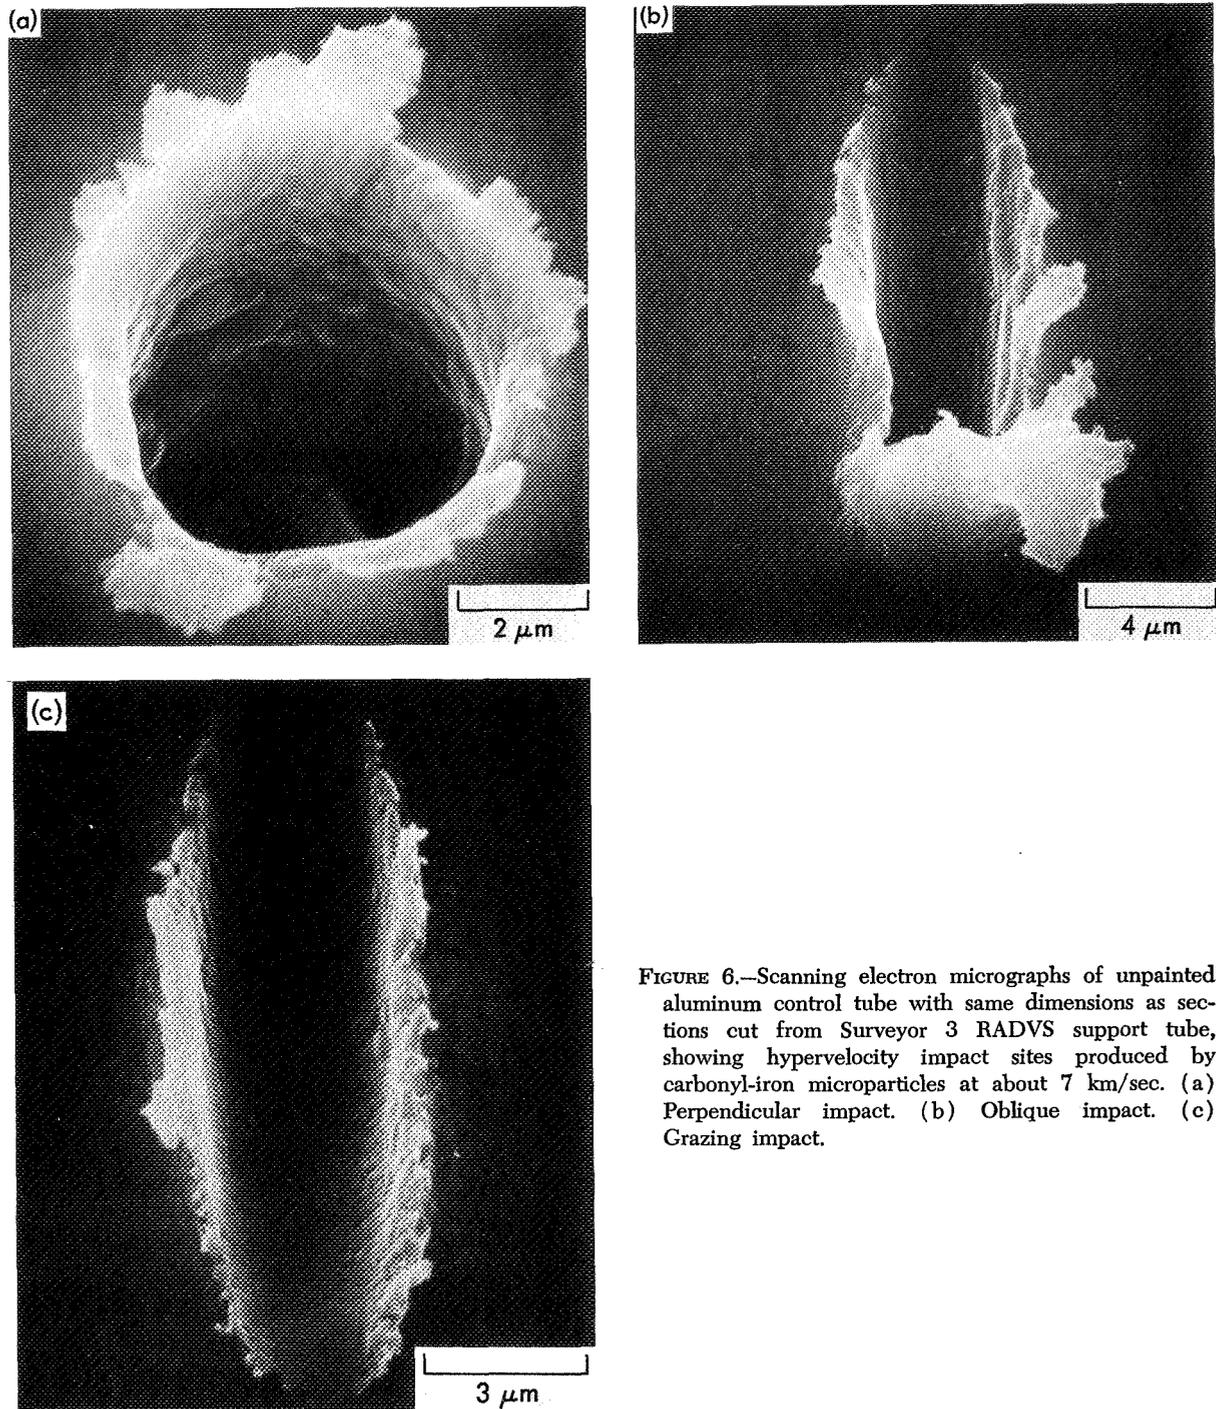
FIGURE 6.—Scanning electron micrographs of unpainted aluminum control tube with same dimensions as sections cut from Surveyor 3 RADVS support tube, showing hypervelocity impact sites produced by carbonyl-iron microparticles at about 7 km/sec. (a) Perpendicular impact. (b) Oblique impact. (c) Grazing impact.

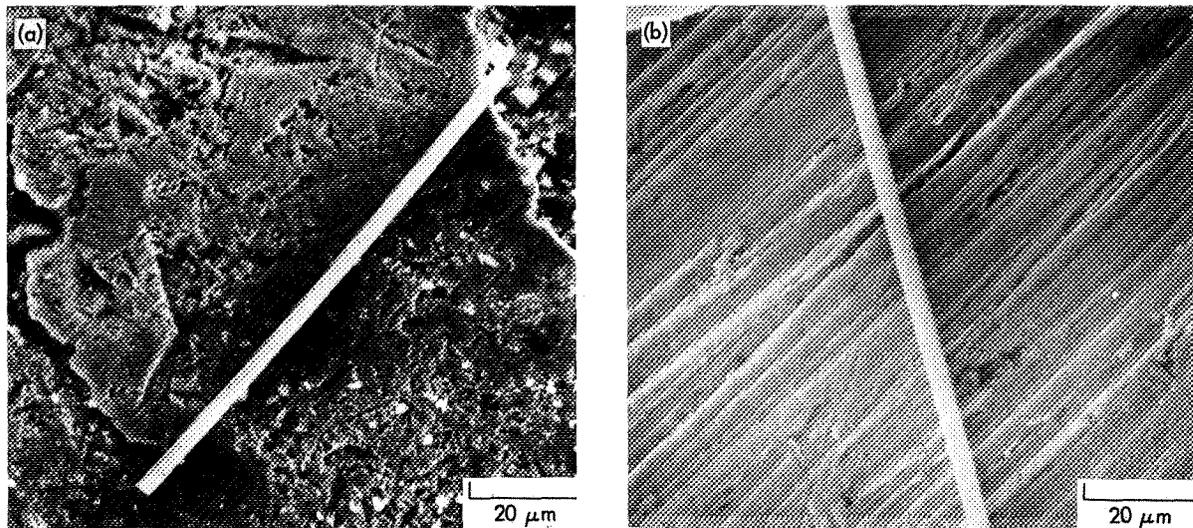
FIGURE 9.—Scanning electron micrographs of rod-like material found on unpainted screw of Surveyor 3 television camera and of fiber taken from beta-cloth space suit material of the Apollo astronauts. (a) Rod-like material on screw surface. (b) Beta-cloth fiber.

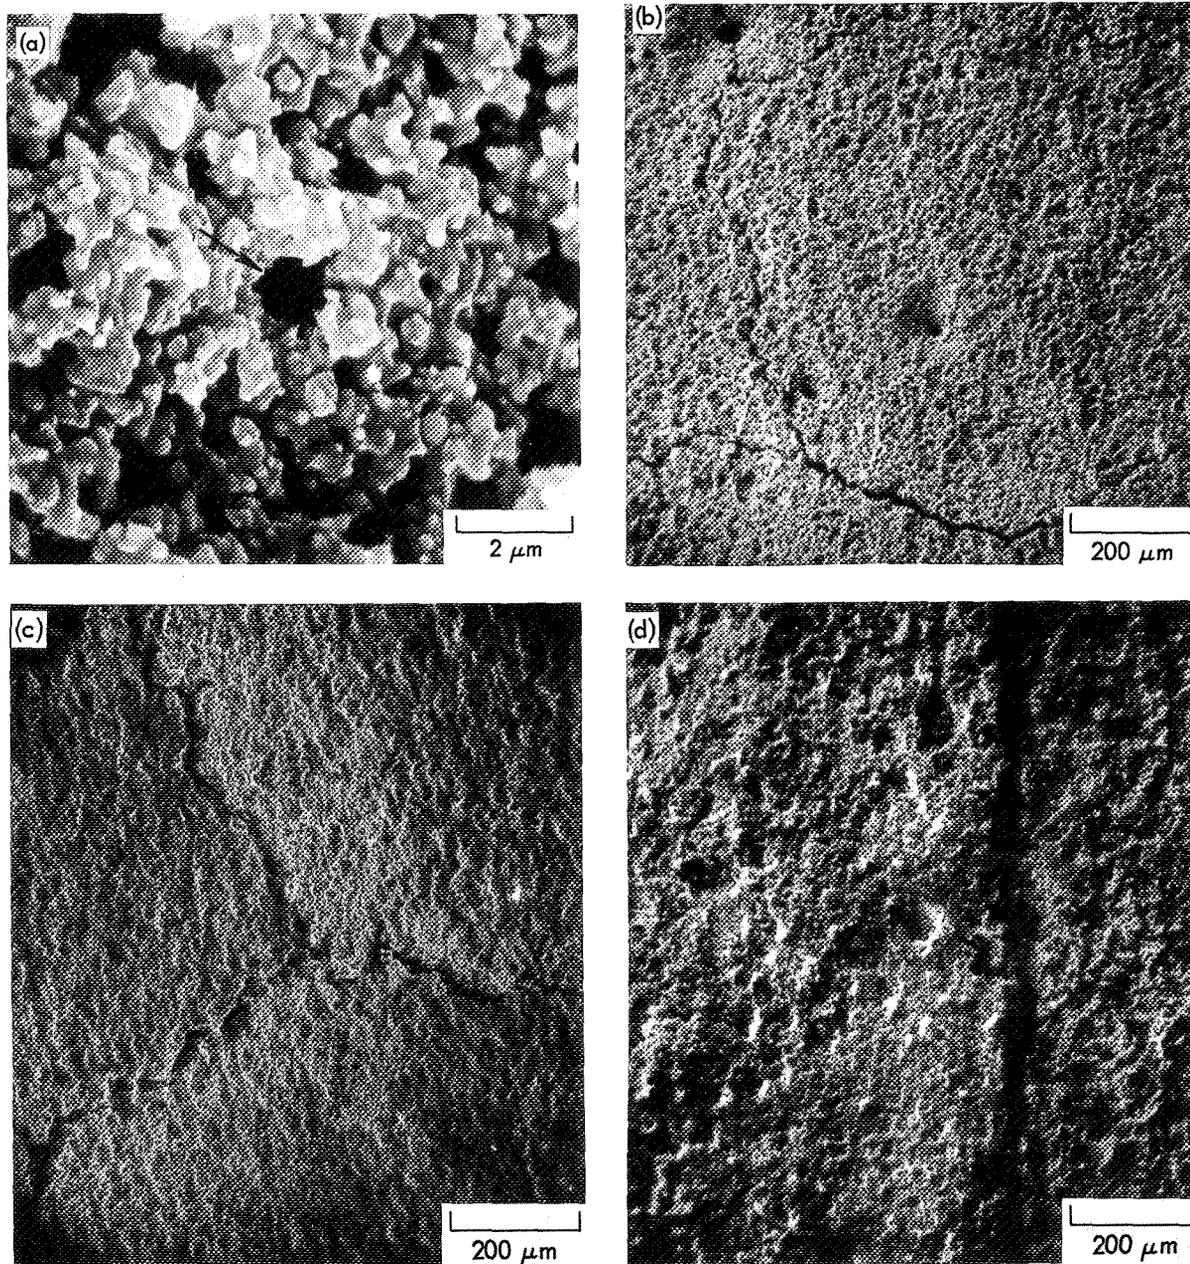
FIGURE 10.—Scanning electron micrographs of thermal-control paints from Surveyor 3 television camera and of laboratory standard thermal-control paint, showing hypervelocity impact sites and/or holes caused by natural porosity of paint. (a) Impact “crater” produced by carbonyl-iron microparticle at about 7 km/sec. (b) Natural-porosity holes in paint standard furnished by Surveyor 3 manufacturer. (c) Holes (or craters) in lower shroud. (d) Holes or craters in elevation-drive housing dust cover.

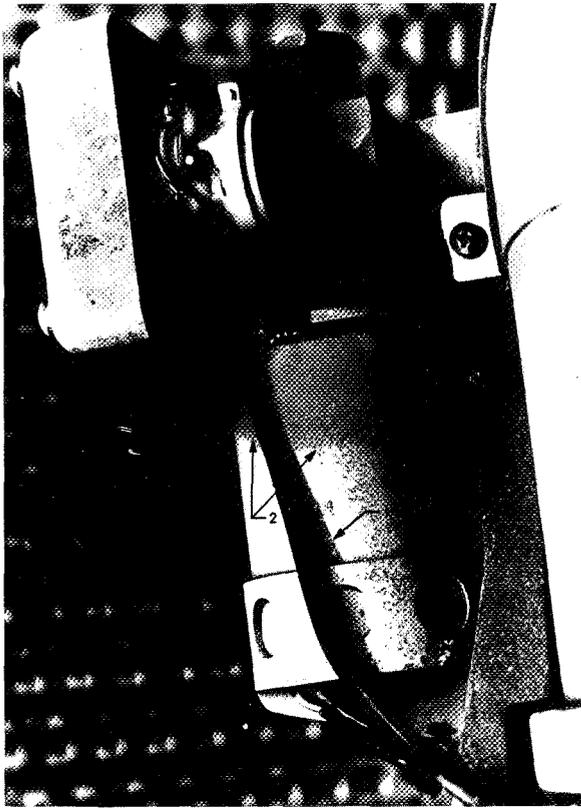
FIGURE 1.—Housing of Surveyor 3 television camera (NASA photograph; contrast enhanced photographically). 1 indicates “permanent shadow” cast by adjacent wire (wire has been moved). 2 indicates “permanent shadow” cast by rectangular cover of the elevation drive train (upper left) onto cylindrical motor housing (at center). This “shadow” covers approximately the upper one-third of the cylindrical portion (arrows). “Shadow” of the lower left corner of the cover falls on the wire.

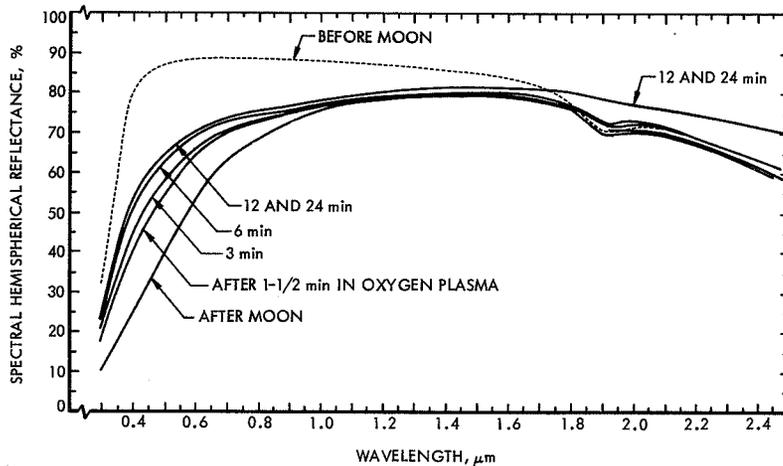
FIGURE 3.—Effect of lunar exposure and subsequent oxygen-plasma treatment on Surveyor plasmoclay coating.

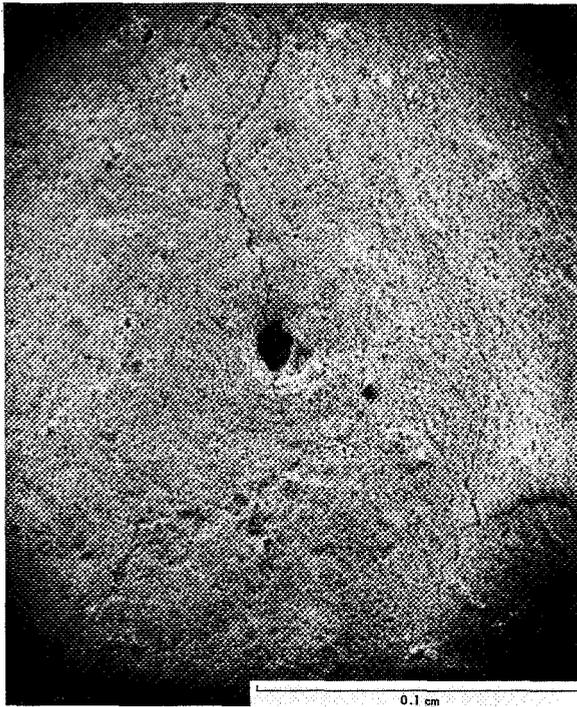
FIGURE 5.—Scanning electron microscope photograph of pit in plasmoclay coating.

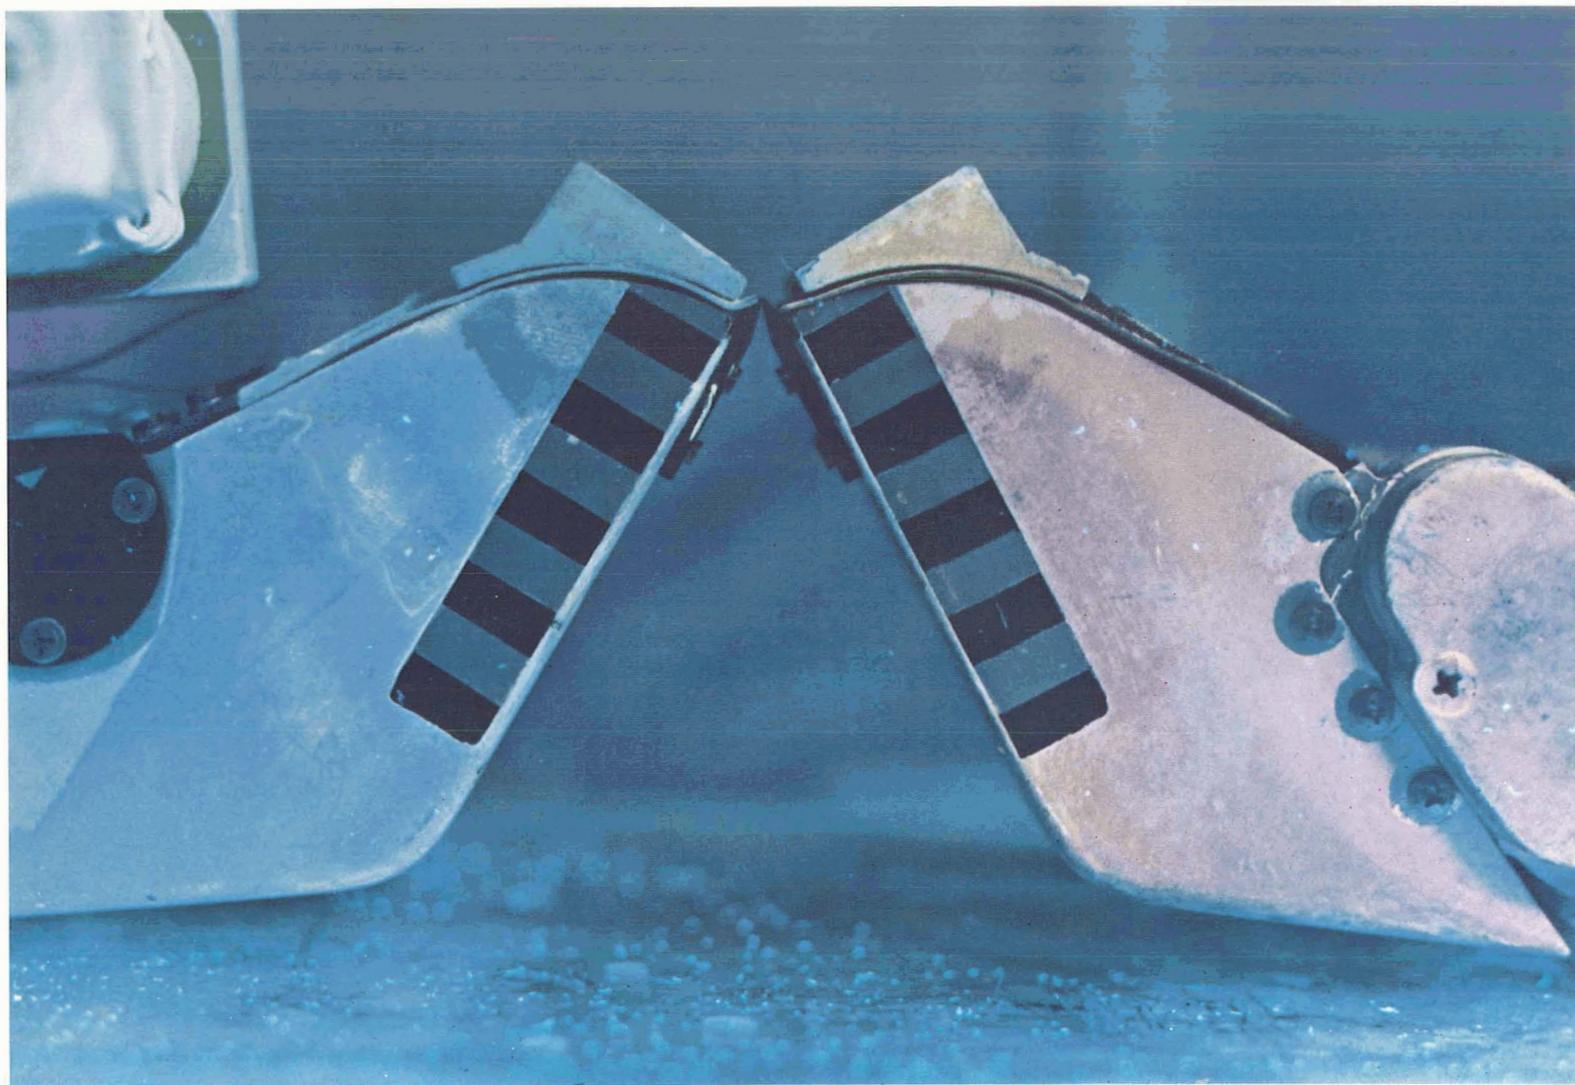
FIGURE 11.—Comparison of right-hand side of Surveyor 3 surface sampler with left-hand side of laboratory surface sampler. Ultraviolet stimulation, visible recorded on film.

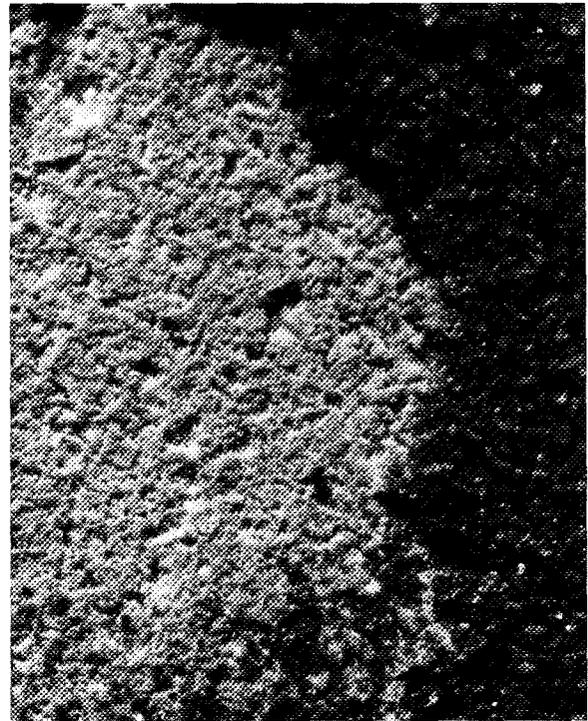
FIGURE 27.—Microphotograph showing cleaned area next to dirty area on painted surface of Surveyor 3 surface sampler (width of field: 3 mm).

is shown in figure 27. By carefully measuring the distance of the nozzle from the surface of the scoop and the radius of the area which was made clean at the critical distance of approach, an estimate could be made of the surface shearing stress required to remove the soil. To make this estimate, the nozzle was calibrated by measuring the mass rate of flux of air into the nozzle at different distances of approach from various flat plates. From these tests, it was estimated that the adhesive strength of the lunar soil to the painted surface was on the order of 10^4 dynes/cm² (0.1 psi). The adhesion of soil to the metallic surfaces of the sampler seemed to be somewhat less and was in the range of 10^3 to 10^4 dynes/cm² (0.01 to 0.1 psi).

It was observed that, in an area of painted surface that had been cleaned by this technique, the remaining particles consisted almost entirely of glassy spheres. This can be seen in a careful examination of figure 27. It would appear that the adhesion of the spheres to the paint, at least, was considerably greater than that of granular fragments of other shapes, as one might expect that angular grains would exhibit a greater degree of mechanical interlocking with a rough surface than spherical particles.

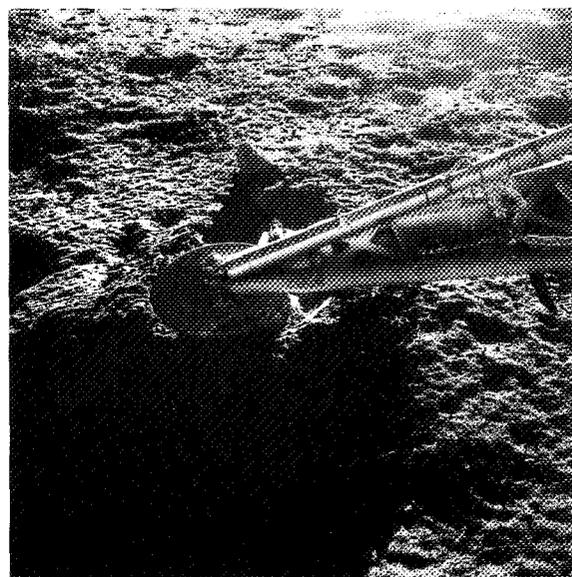
FIGURE 4.—Astronaut photograph of footpad 3 and part of leg 3. The collapsed shock absorber is the upper tubular member. The footpad shows some soil, with adjacent lighter colored areas (AS12-48-7124).

The Surveyor spacecraft moved from its landed configuration sometime between May 1967 and November 1969. It is conjectured that the movement occurred as a result of a sudden failure of the leg 3 shock absorber. The movement at footpad 2 was in the amount of 5° of tilt and 7 to 8 cm of lateral translation in the form of a rotation about footpad 1, which was embedded in the lunar soil.

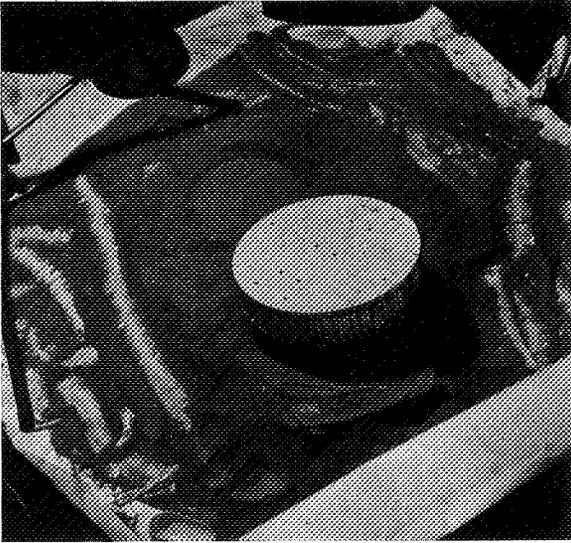
FIGURE 6.—Laboratory photograph simulating position of Surveyor 3 footpad 2, and lunar soil imprints. Picture taken from Surveyor 3 camera position for comparison with figure 1. In this picture, *both imprints* visible in figure 5 are present in their correct positions relative to each other, but the second imprint is concealed from the camera by the footpad.

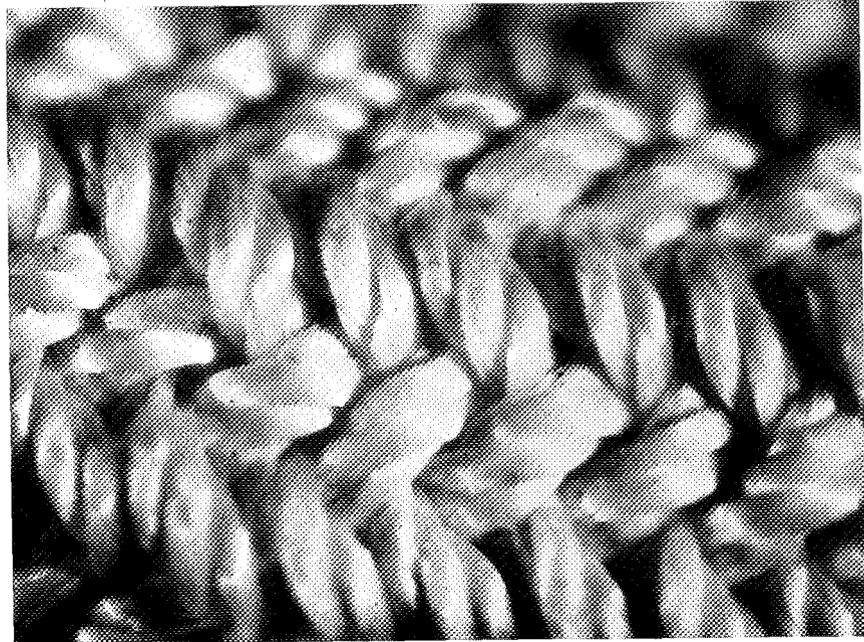
FIGURE 2.—Enlarged view (magnified 20 \times) of woven glass fabric; black particles are believed to be Moon dust.

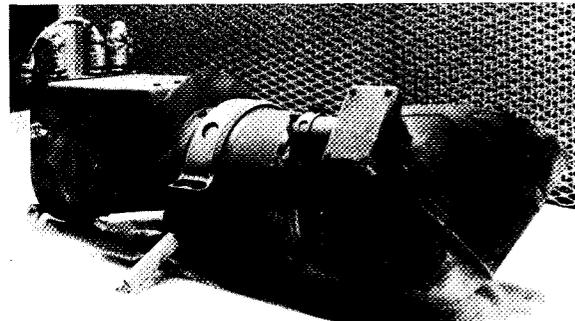
FIGURE 4.—View of the Surveyor 3 camera as seen from the Lunar Module.

angle, darker "shadows," which are free of a large crater density, are lined with protuberances such as bolts, screw heads, and other parts of the camera. These shadows are noticeable on the mirror hood in figure 4, on the base of the camera where it was partly shielded by a plate, and near the screw heads on the mirror gear box. Figures 5 and 6 are enlargements of two of those screw heads. Note that the shadow in figure 6 is well defined, and that numerous white chipouts are found outside the shadowed region. (The darker shadow extending downward is due to the light source used to take the picture and is not a permanent feature of the surface.) Figure 7 is a top view of the camera and shows the shadow cast by the bolt with the hexagonal head.

Figure 4 shows the apparatus used to hold the camera onto the Surveyor, along with the shadows it casts. The shadows are seen in figure 8, in which the mounting tubes have been removed.

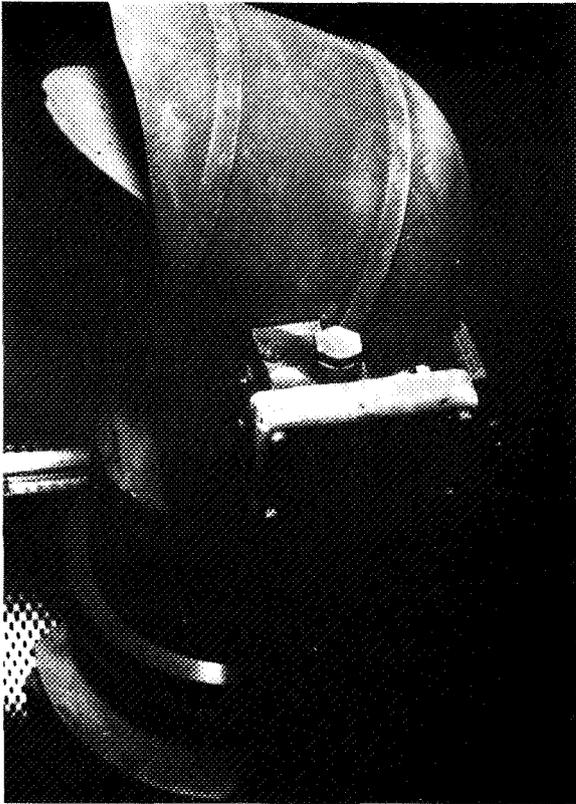
FIGURE 5.—Evidence of particle impact shadows on the camera housing.

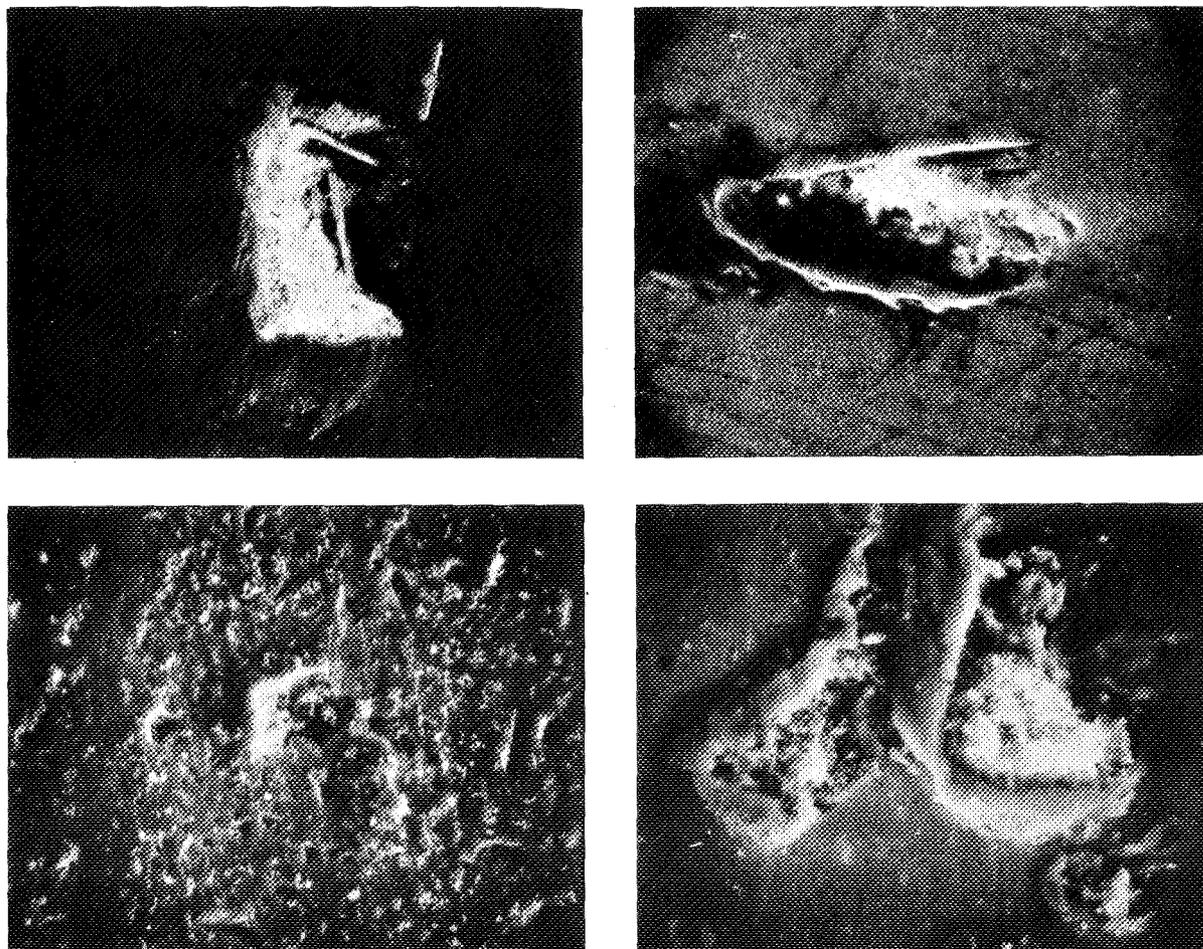
FIGURE 12.—Evidence of typical impact debris found on sections B and C of the Surveyor 3 polished tube.
